June 2, 2016

Re: Geotechnical Engineering Assessment of Dairy Farm Storage Pond Berm
4207 West Linwood Avenue, Turlock, California
SFB Project No.: 727-1

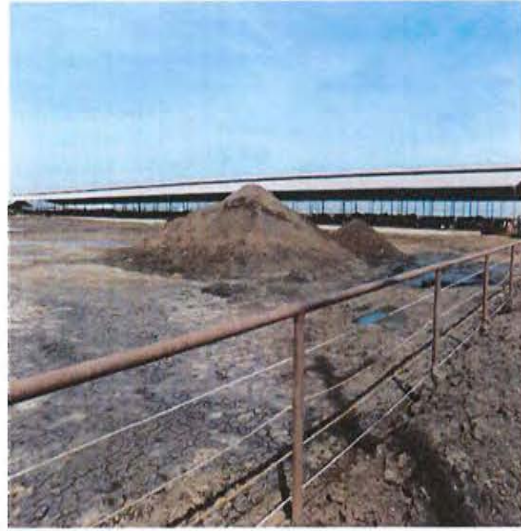
Photo of manure piled in a corral.

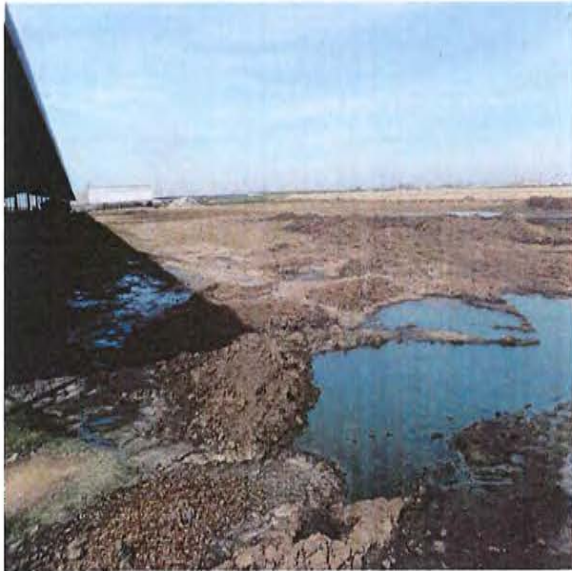
Photo of ponding in a corral.

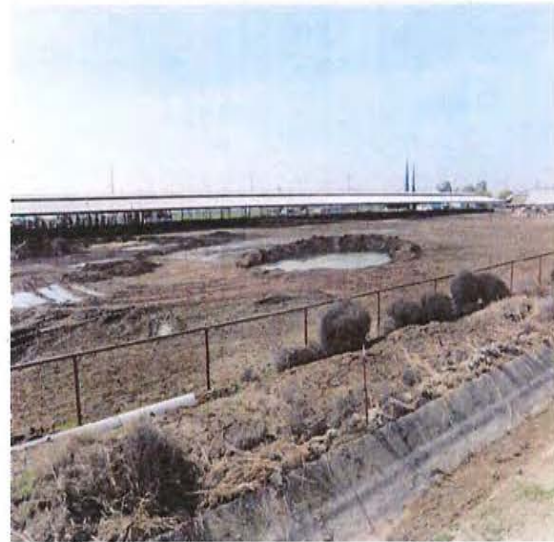
Photo of a crater in a different corral with standing water.

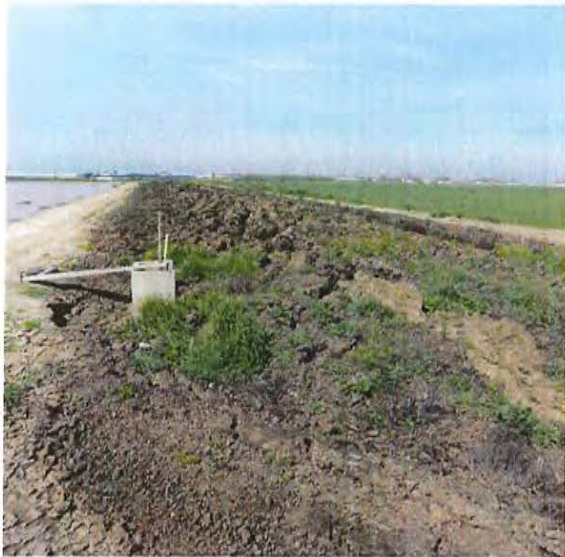
Photo of the settling basin. Note it is extremely full.

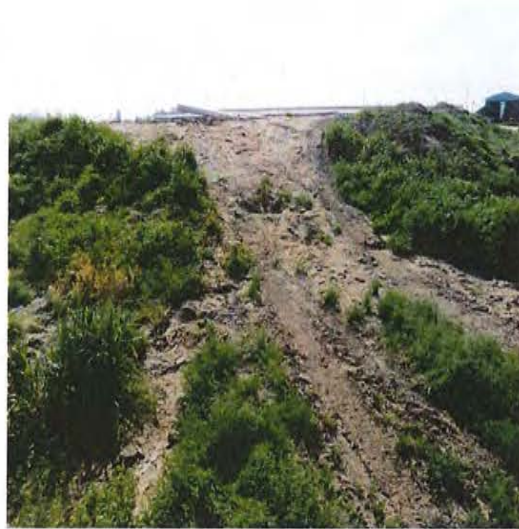
Photo of the settling basin embankment where wastewater overflowed onto adjacent cropland.

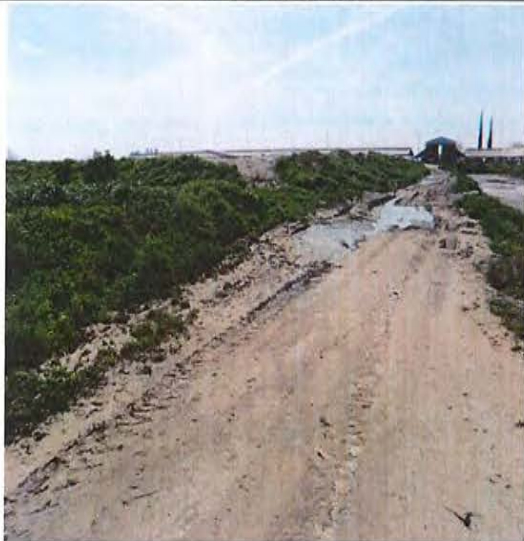
Photo of process wastewater at the toe of the embankment from the overflowing settling basin.

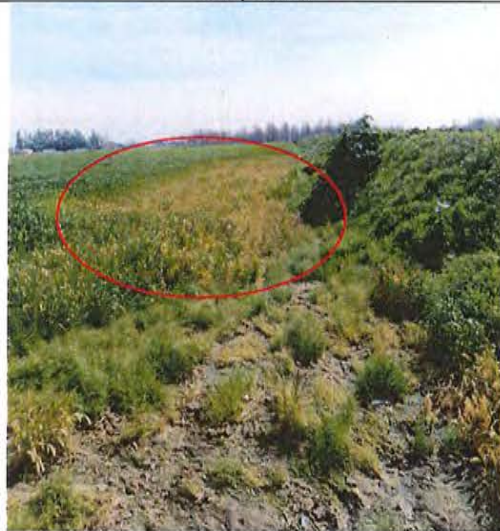
Photo of cropland that was affected from the overflowing settling basin. Note that the crop circled in red is burnt.

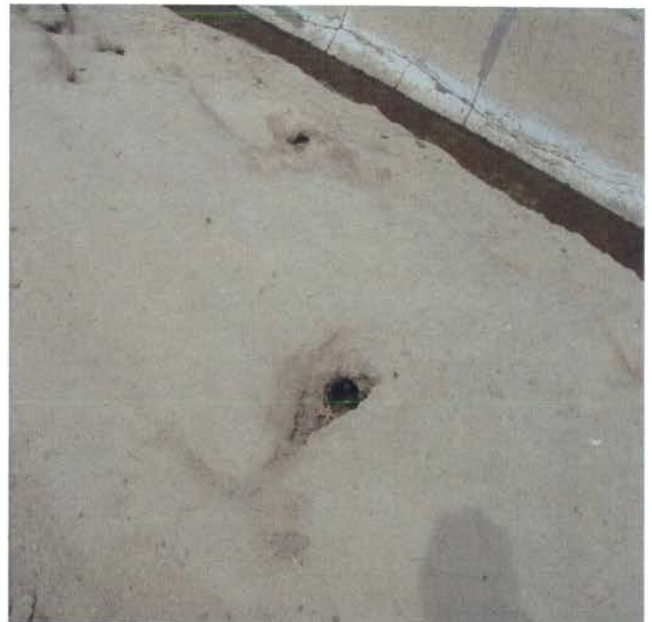
Phone 6: Holes on the berm of storage lagoon

The corrals should be graded and sloped to divert corral runoff into the storage lagoon. The manure storage area should have a drainage system to direct runoff into the storage lagoon. The wastewater storage lagoon should be maintained free from holes and animal burrows.

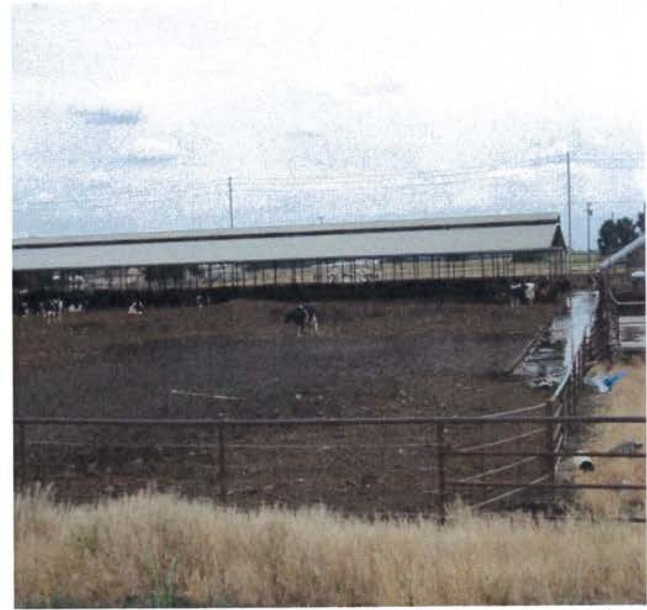
Phone 12: North side corral with sign of corral ponding

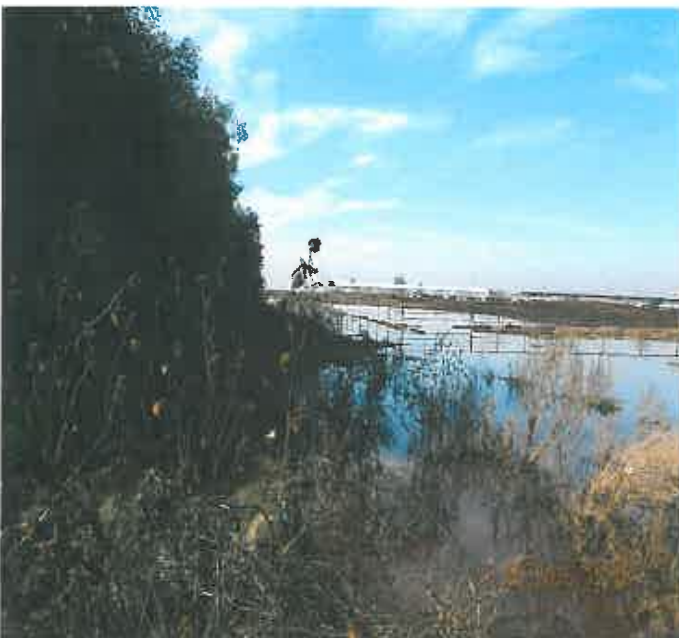
Photo 3: Wastewater ponding in west side corral

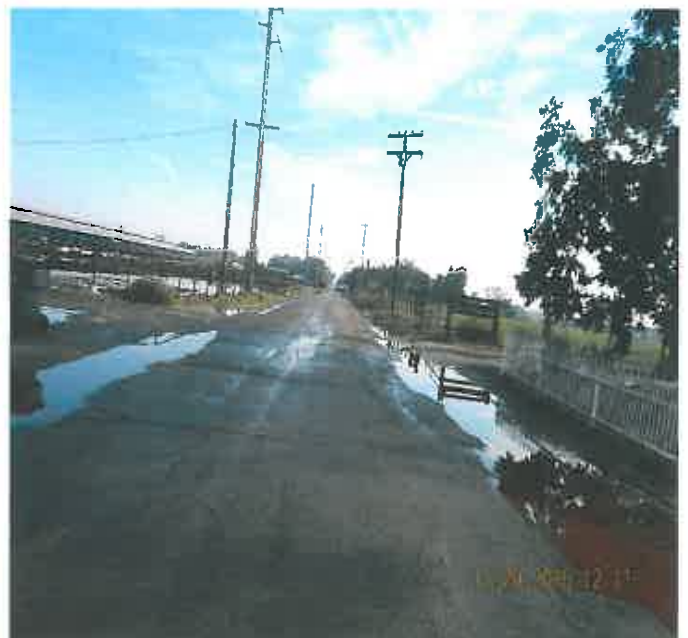
Photo 4: Wastewater ponding along Linwood Avenue (west to east view)

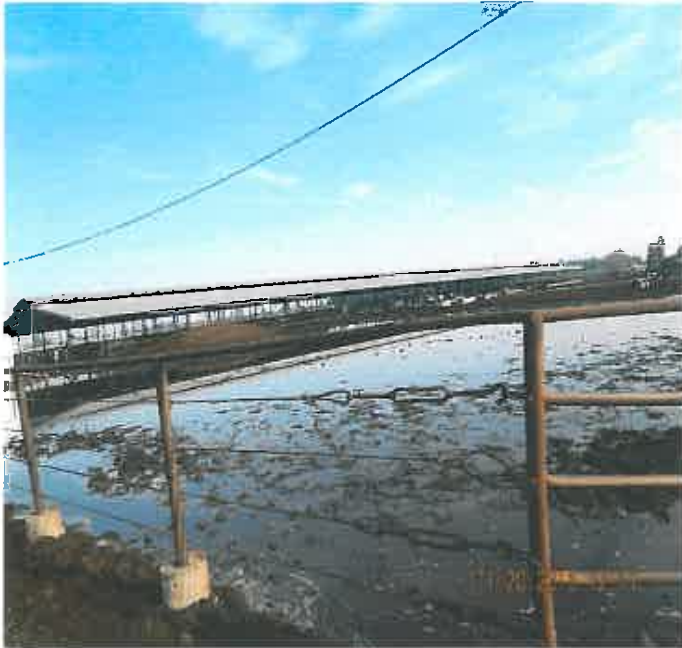
Photo 5: Wastewater ponding in south side corral

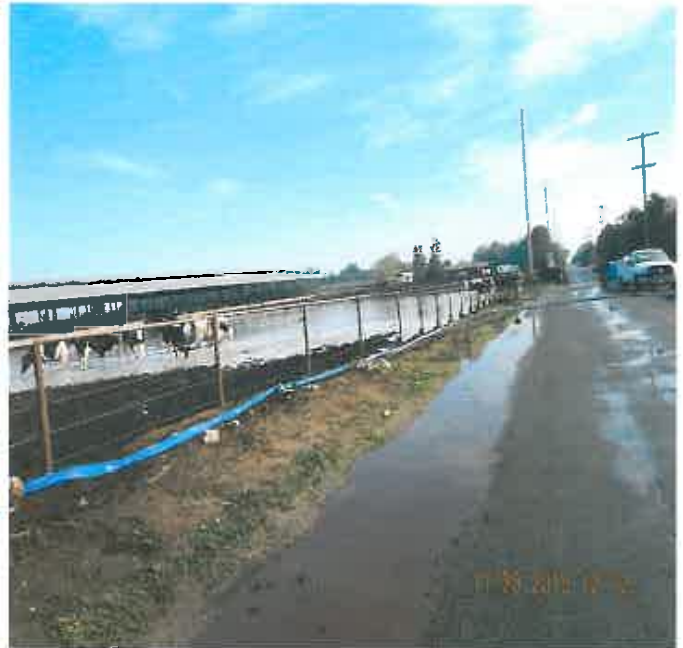
Photo 6: Wastewater ponding in south side corral; wastewater being pumped back from residential areas in to corrals and then to pond

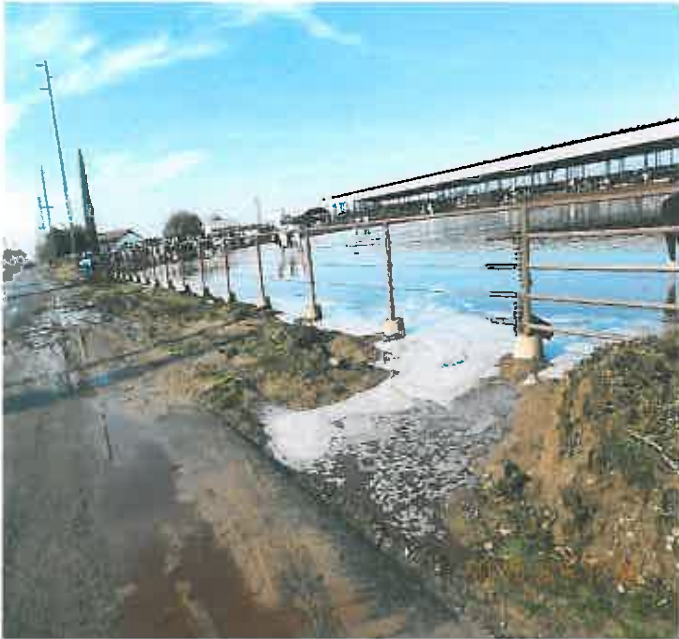
Photo 21: Wastewater ponding in south side corral and on road side (east to west view)

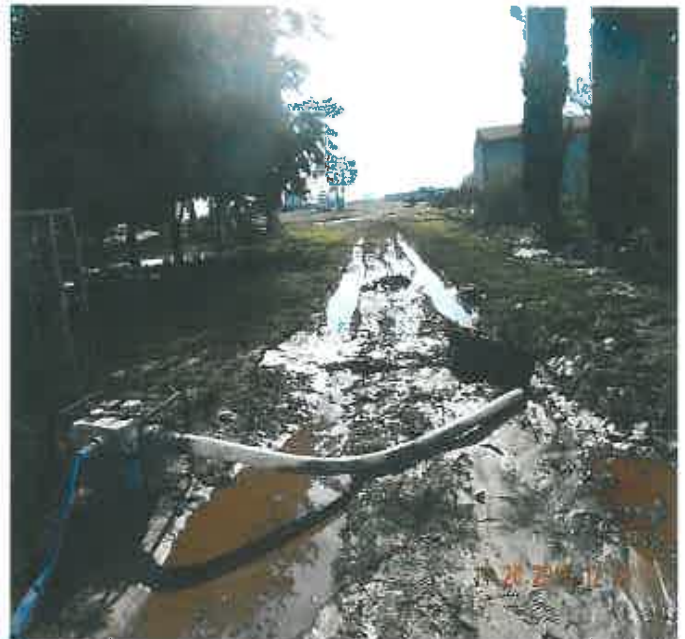
Photo 22: Wastewater being pumped from residential area into the corrals

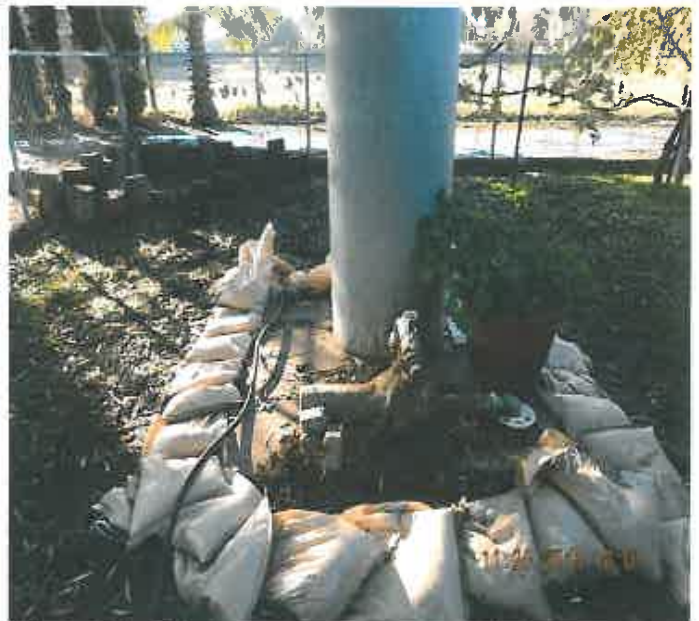
Photo 24: Wastewater reached wells in residential area

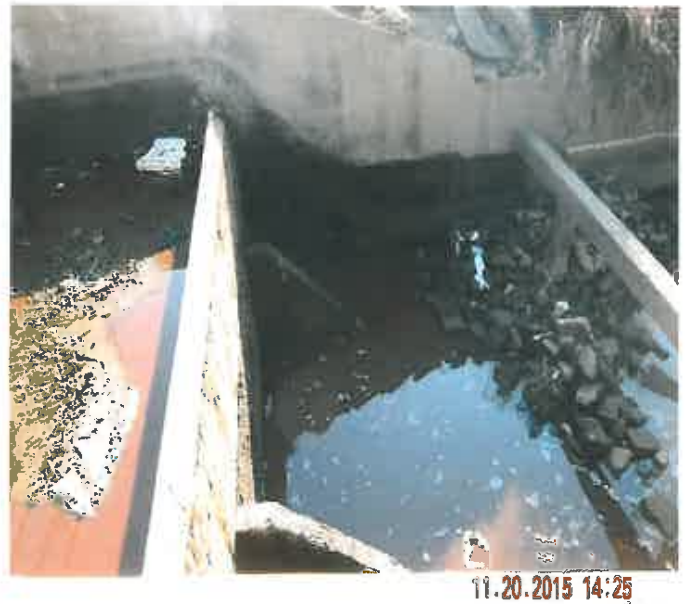
Photo 26: Wastewater leaked into Harding Drain

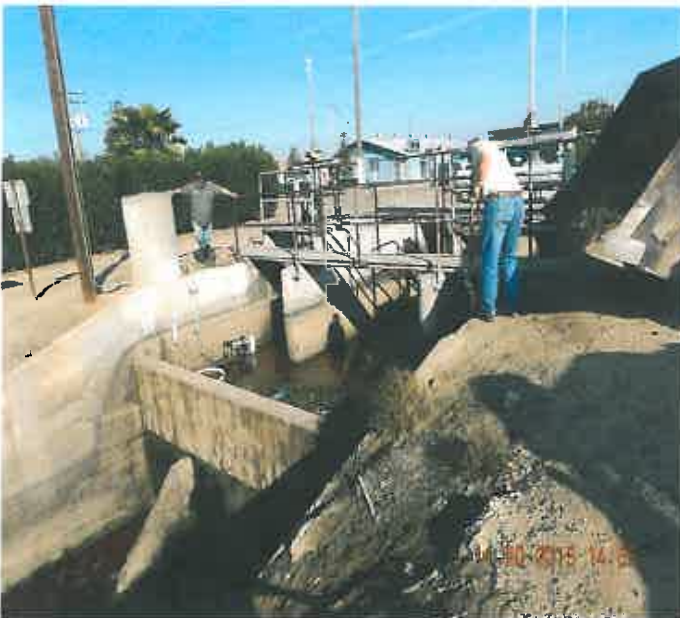
Photo 27: Wastewater in Harding Drain; the leaking area was being closed

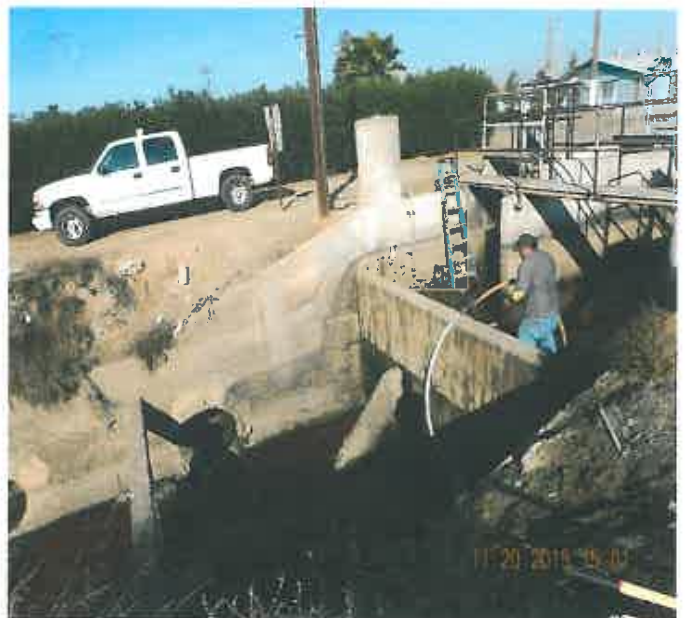
Photo 28: Wastewater in Harding Drain: attempt to pump wastewater from the drain
